LUX Audio of America Ltd.

April 26, 1978

TO: ALL LUX SERVICE STATIONS

SUBJECT: ADJUSTMENT FOR UNSTABLE SPEED ON PD-441/PD-444

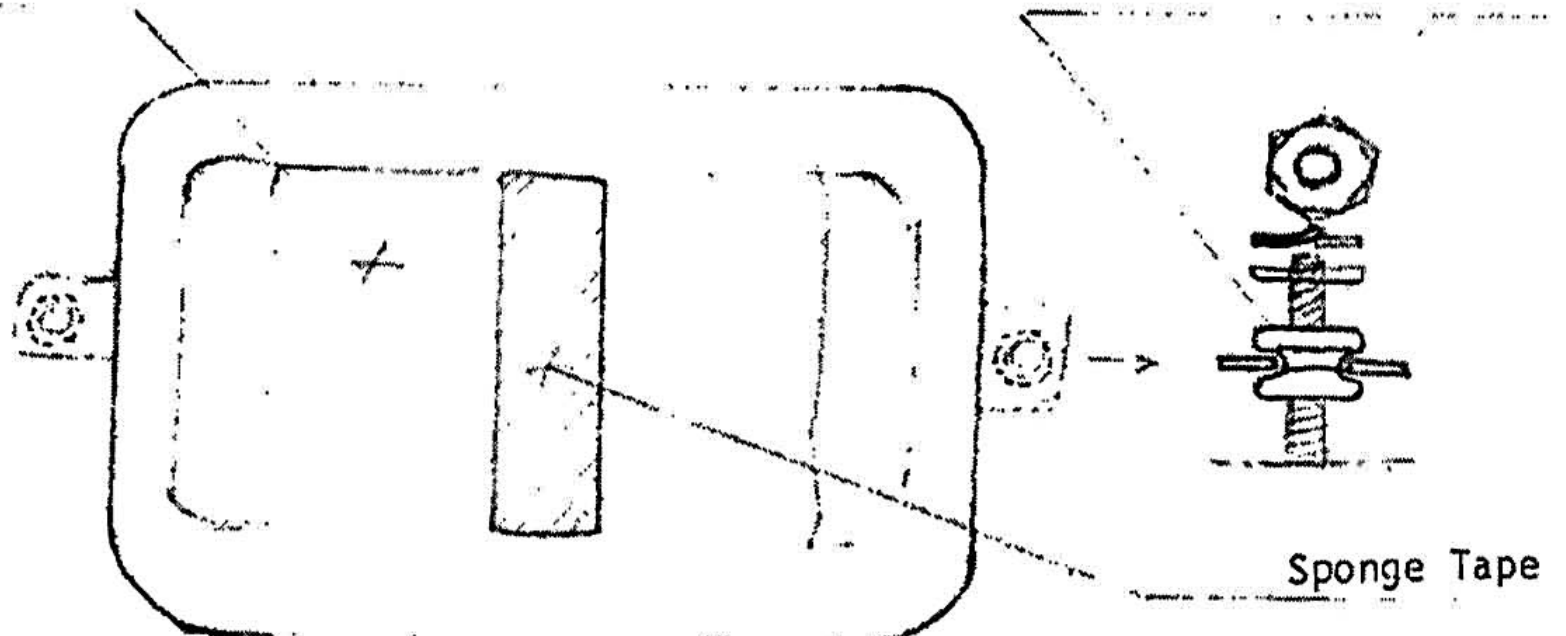
Transformer

Rubber Bushing

1. Remove the name plate from the motor cover located on the under-side of the unit.
2. Remove the motor cover (be careful not to damage the rubber bushing).
3. Adjust the D.C. voltage on both sides of R12 on the circular Printed Circuit Board to equal:
