Ref #: SR500LFE-01-VID

Title: TX-SR500

Classification: Mandatory Service Bulletin

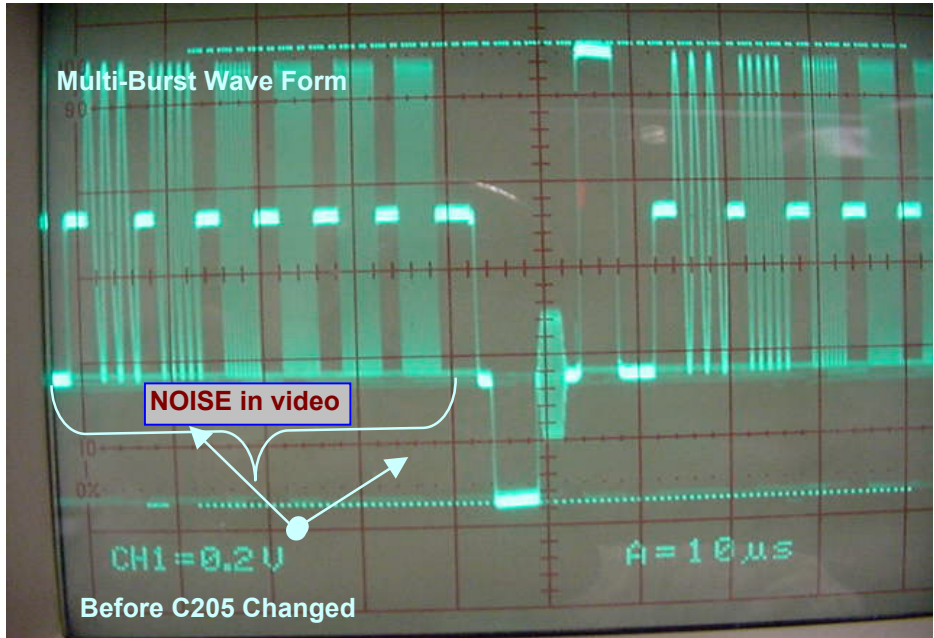
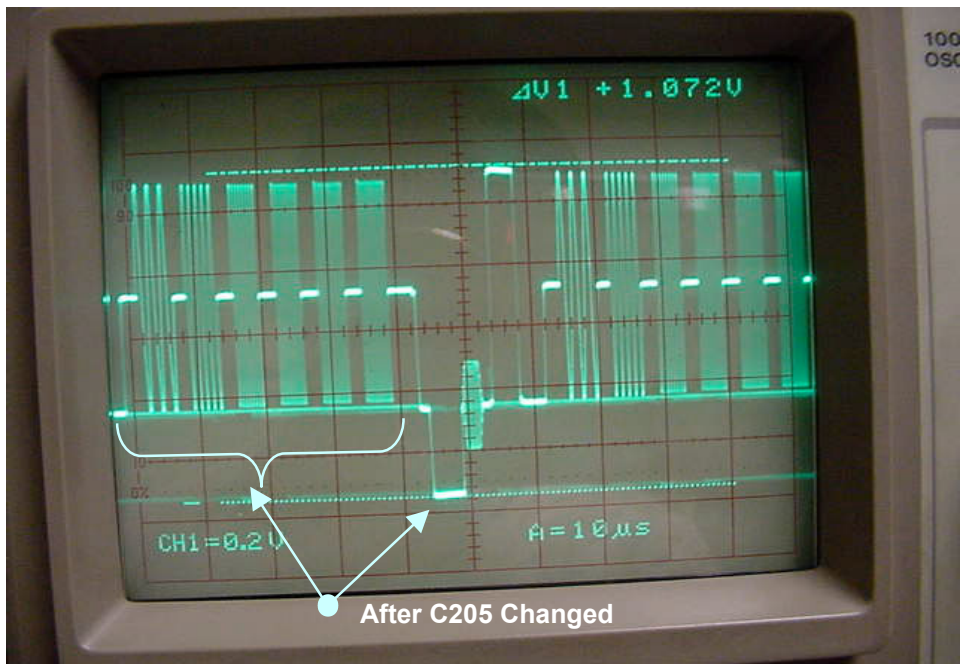
Symptom: 2) In production lower value of capacitors were used on PCB NAVD-7422, locations C C203, C205, C211, and C215 that may cause Video jitter, Vertical roll and Video mute in TV-Monitors.

In HT-R500 a change in C205 from its current value 100uf16V capacitor to 1000/6.3V will help eliminate the ringing and jitter in video waveform.

Solution: 2) C203, C205, C211, and C215 must be changed from their current value of 47uf or 100uf to 1000uf. Please refer to page #2 bulletin "TR500-SR500-VID" for solution.
