Sansui SERVICE BULLETIN

Ref. CE-013

Subject: MODIFICATION OF THE POWER CIRCUIT
 Model: 2000A

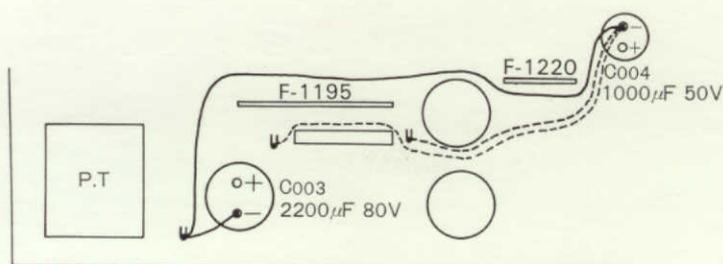
1. If noise (input shorted) is noticeable in the power amplifier sections, change the connecting wire and grounding point in the power circuit.
 See Fig. below:
