marantz® SERVICE BULLETIN		Date: 16-Mar.-2004	Model: DV-12S2
		Page: 1 / 1	REF.NBR: MZ04-028
Circulation:		Application:	
x for information customer complaint in case of service mandatory		Only Lot number MZxxxxxx01xxxx	
		Subject: Can not set the PAL progressive mode.	
		Int.ref:

marantz® SERVICE BULLETIN		Date: 27-Feb.-2004	Model: DV-12S2
		Page: 1 / 1	REF.NBR: MZ04-018
Circulation:		Subject:	
Application:		Output signal distortion.	
x for information customer complaint in case of service mandatory			
		See Below

marantz® SERVICE BULLETIN		Date: 17-Mar.-2004	Model: SA-12S1
		Page: 1 / 1	REF.NBR: MZ04-030
Circulation:		Application:	
x for information customer complaint in case of service mandatory		See below	
		Subject: Can not playback specific DVD Disc.	
		Int.ref:

marantz® SERVICE BULLETIN		Date: 17-Mar.-2004	Model: SA-12S1
		Page: 1 / 1	REF.NBR: MZ04-029
Circulation:		Subject:	
Application:		Stop during Repeat playback mode.	
x for information customer complaint in case of service mandatory			
		See below

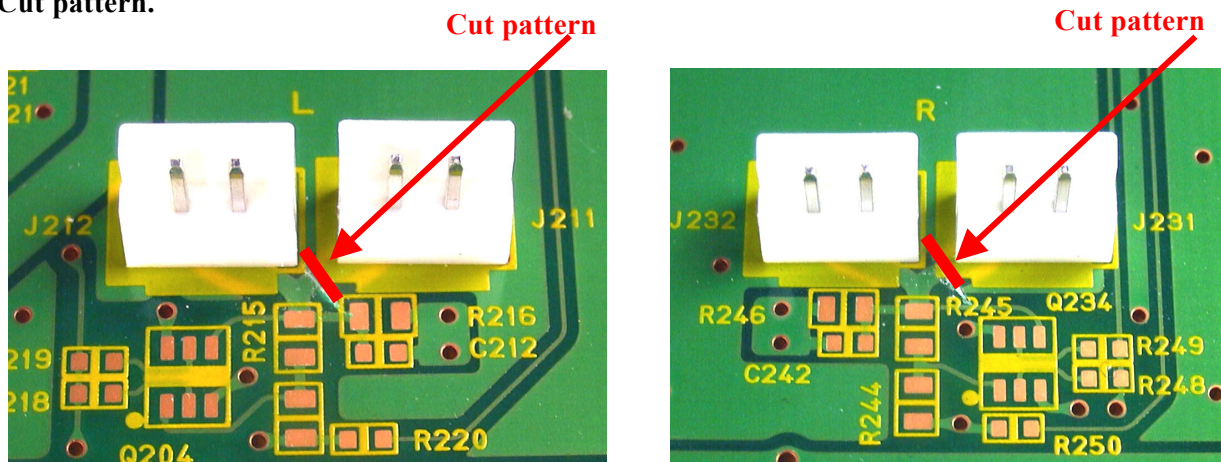
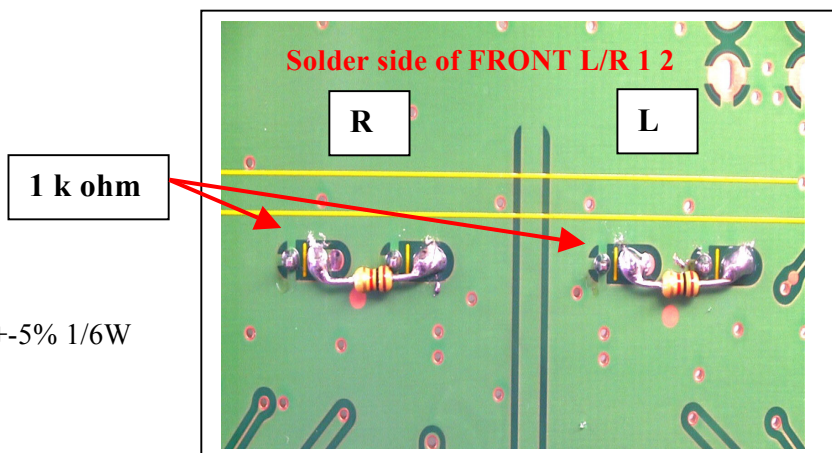
On the PA01-AUDIO CIRCUIT BOAD

- 1) FRONT L/R 1 2 and SURR.L/R, CENTER L/R, SUB W L/R of AUDIO OUTPUT are simultaneously Connected to amplifier.
- 2) If the Amplifier which used the electronic switch is turned off, another sound will be distorted.

FRONT L/R 1 2 are connected parallel, therefore, if the Amplifier input of another side short-circuits, it will influence

1. Resistor 1k ohm is added to 2 of FRONT L/R 1 2.
2. Cut pattern.

Carbon film fixed resistor, 1k ohm +-5% 1/6W
(part no. GD05102160)

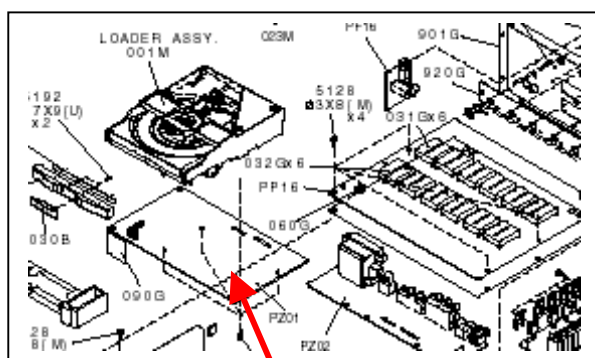
MONO (PZ01) CIRCUIT BOARD

The part defect of Digital Servo Controller IC SAA7399HL.
(It occurs only in specific IC SAA7399HL up to week code 0346)

1) Replace IC SAA7399HL (7207) on the MONO (PZ01) CIRCUIT BOARD.

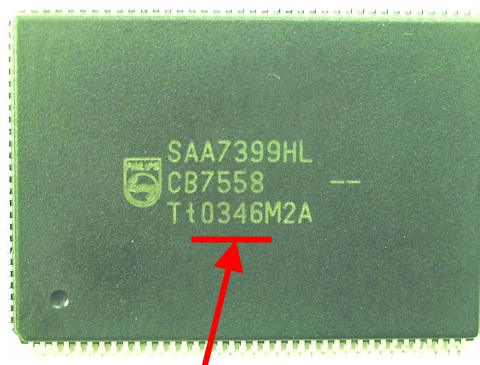
week code is the following.

Fault is up to week code 0346.
It has been improved from week code 0347.

- 1) The part number isn't changed.
- 2) The distinction of fault and Improvement IC can be checked in week code on IC.
- 3) Fault is up to week code 0346. It has been improved from week code 0347.
- 4) Improved IC is delivered when IC is newly ordered to the MJI Spare parts center (ware house).
