SERVICE BULLETIN

Model: 2300 Stereo Power Amplifier

Serial Numbers: 01000 thru 01250

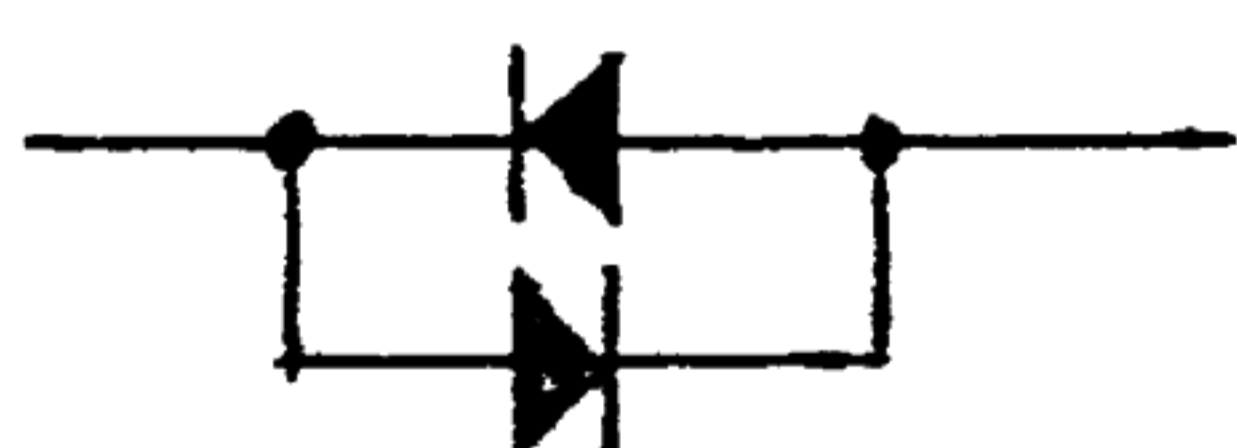
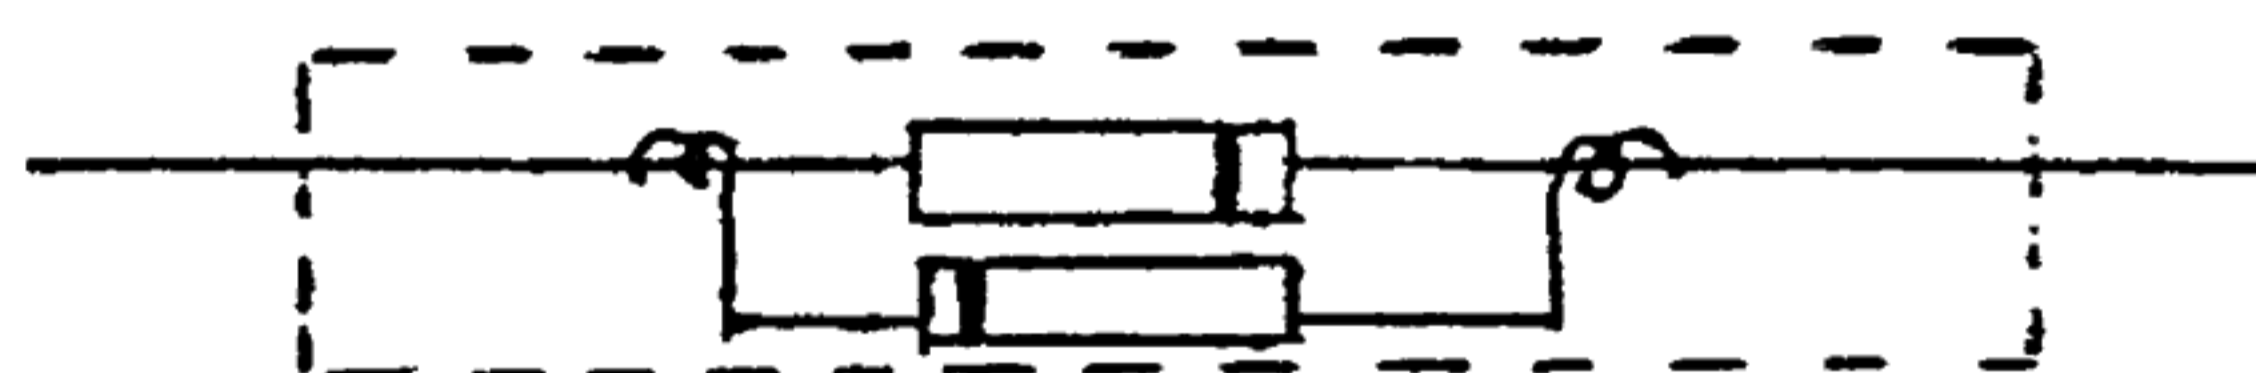
Problem: Possible damage to input differential amplifier transistors from high level input signals (overload condition) in turn causing output transistor failure.

1. Remove unit top and side covers. Examine foil side of left and right channel drive boards. Diodes will be added to foil side on both boards and may already be in place.
2. Fabricate a diode assembly by connecting two diodes back-to-back in parallel, solder the leads together, cover the diodes and leads with shrink sleeving exposing 1/8" lead at each end then shrink the sleeving with heat from the heat gun. Use minimal amount of heat to prevent junction damage.
