LUX Audio of America Ltd.

April 26, 1978

TO: ALL LUX SERVICE STATIONS

SUBJECT: ADJUSTMENT FOR UNSTABLE SPEED ON PD-441/PD-444

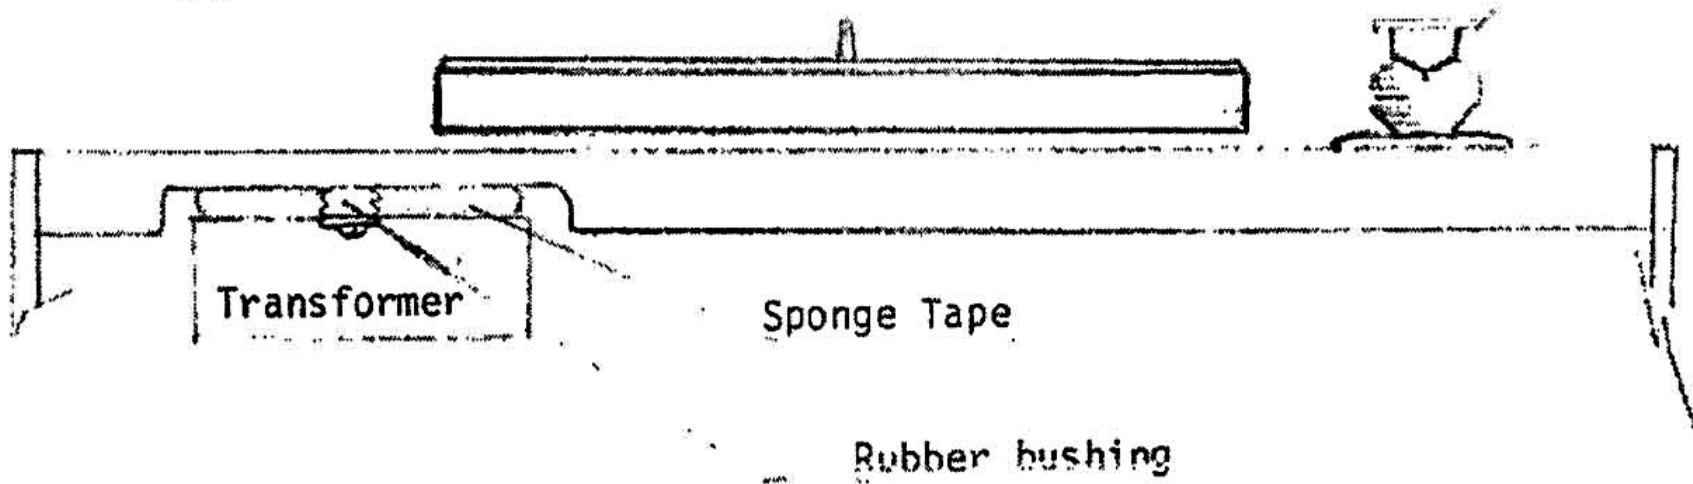
It has been brought to our attention that occasionally, the servo lock system may become intermittent or cut out completely on the PD-441 and PD-444. Should you encounter this situation, the remedial action is as follows:

1. Remove the name plate from the motor cover located on the under-side of the unit.
2. Remove the motor cover (be careful not to damage the rubber bushing).
3. Adjust the D.C. voltage on both sides of R12 on the circular Printed Circuit Board to equal:

<u>Speed</u>	<u>Adjustment</u>	<u>Voltage</u>
45 rpm	VR02	8.5v at 10°C (50°F)
33 1/3 rpm	VR01	7.5 volts at 20°C (68°F) 6.0v at 30°C (86°F)

Note: Variable Resistor (VR) must be turned very slowly. 33 1/3 rpm should be set first and then 45 rpm. Also, the platter of the unit must be in place and turning when making this adjustment. I realize that this is difficult but possibly having the unit right side up and reaching underneath to make the adjustment and measurements.
