marantz® SERVICE BULLETIN		Date: 16-Mar.-2004	Model: DV-12S2
		Page: 1 / 1	REF.NBR: MZ04-028
Circulation:		Application:	
x for information customer complaint in case of service mandatory		Only Lot number MZxxxxxx01xxxx	
		Subject: Can not set the PAL progressive mode.	
		Int.ref:

marantz® SERVICE BULLETIN		Date: 27-Feb.-2004	Model: DV-12S2
		Page: 1 / 1	REF.NBR: MZ04-018
Circulation:		Subject:	
Application:		Output signal distortion.	
x for information customer complaint in case of service mandatory			
		See Below

marantz® SERVICE BULLETIN		Date: 17-Mar.-2004	Model: SA-12S1
		Page: 1 / 1	REF.NBR: MZ04-030
Circulation:		Application:	
x for information customer complaint in case of service mandatory		See below	
		Subject: Can not playback specific DVD Disc.	
		Int.ref:

marantz® SERVICE BULLETIN		Date: 17-Mar.-2004	Model: SA-12S1
		Page: 1 / 1	REF.NBR: MZ04-029
Circulation:		Subject:	
Application:		Stop during Repeat playback mode.	
x for information customer complaint in case of service mandatory			
		See below

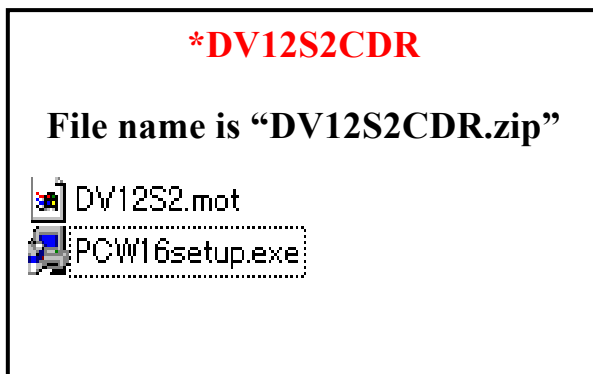
ON/ OFF timing of Press the PROGRESSIVE button on the Front Panel, can not set the PAL progressive mode, the phenomenon is sometimes happened.

1) Update the Main microprocessor (QU01) software version to [**Ver 2.10**]

Update of the firmware disc ***DV12S2CDR**
