Title: **ISA Turn-on Hangup**
Bulletin #: ISA0001 Issue Date: April 4, 2002
Models Affected: ISA 750, 800T, 450, & 500T
Bulletin Revision: A
Production Range: 01/2000–04/2002 (serial # 0100xxxxx–0402xxxxx)

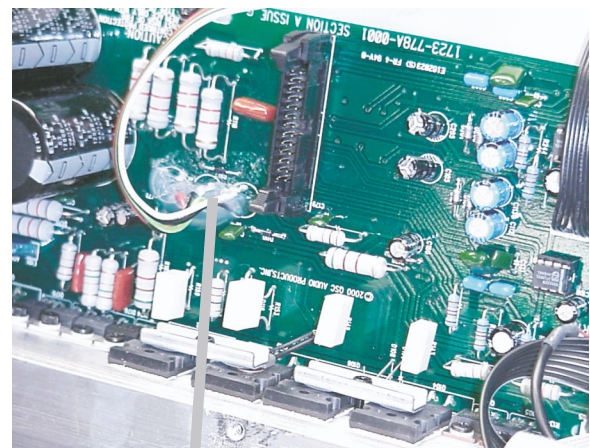
Figure 3. You might need to clear hot glue away from diode D107. Use your hot soldering iron tip.

6. Disconnect the ribbon cable from the channel 1 module.
7. Locate zener diode D107. It is near where three wires are soldered to the circuit board and secured with hot glue. If the hot glue covers the diode, use the tip of your hot soldering iron and a small screwdriver to melt and clear the glue away (Figure 3).
